ASBESTOS RE-INSPECTION SURVEY REPORT

AUBURN ADMINISTRATION BUILDING
GSA BUILDING NUMBER WA0811KA
400 15th STREET SW
AUBURN, WASHINGTON

ASSESSMENT DATE:
10-19- 2012

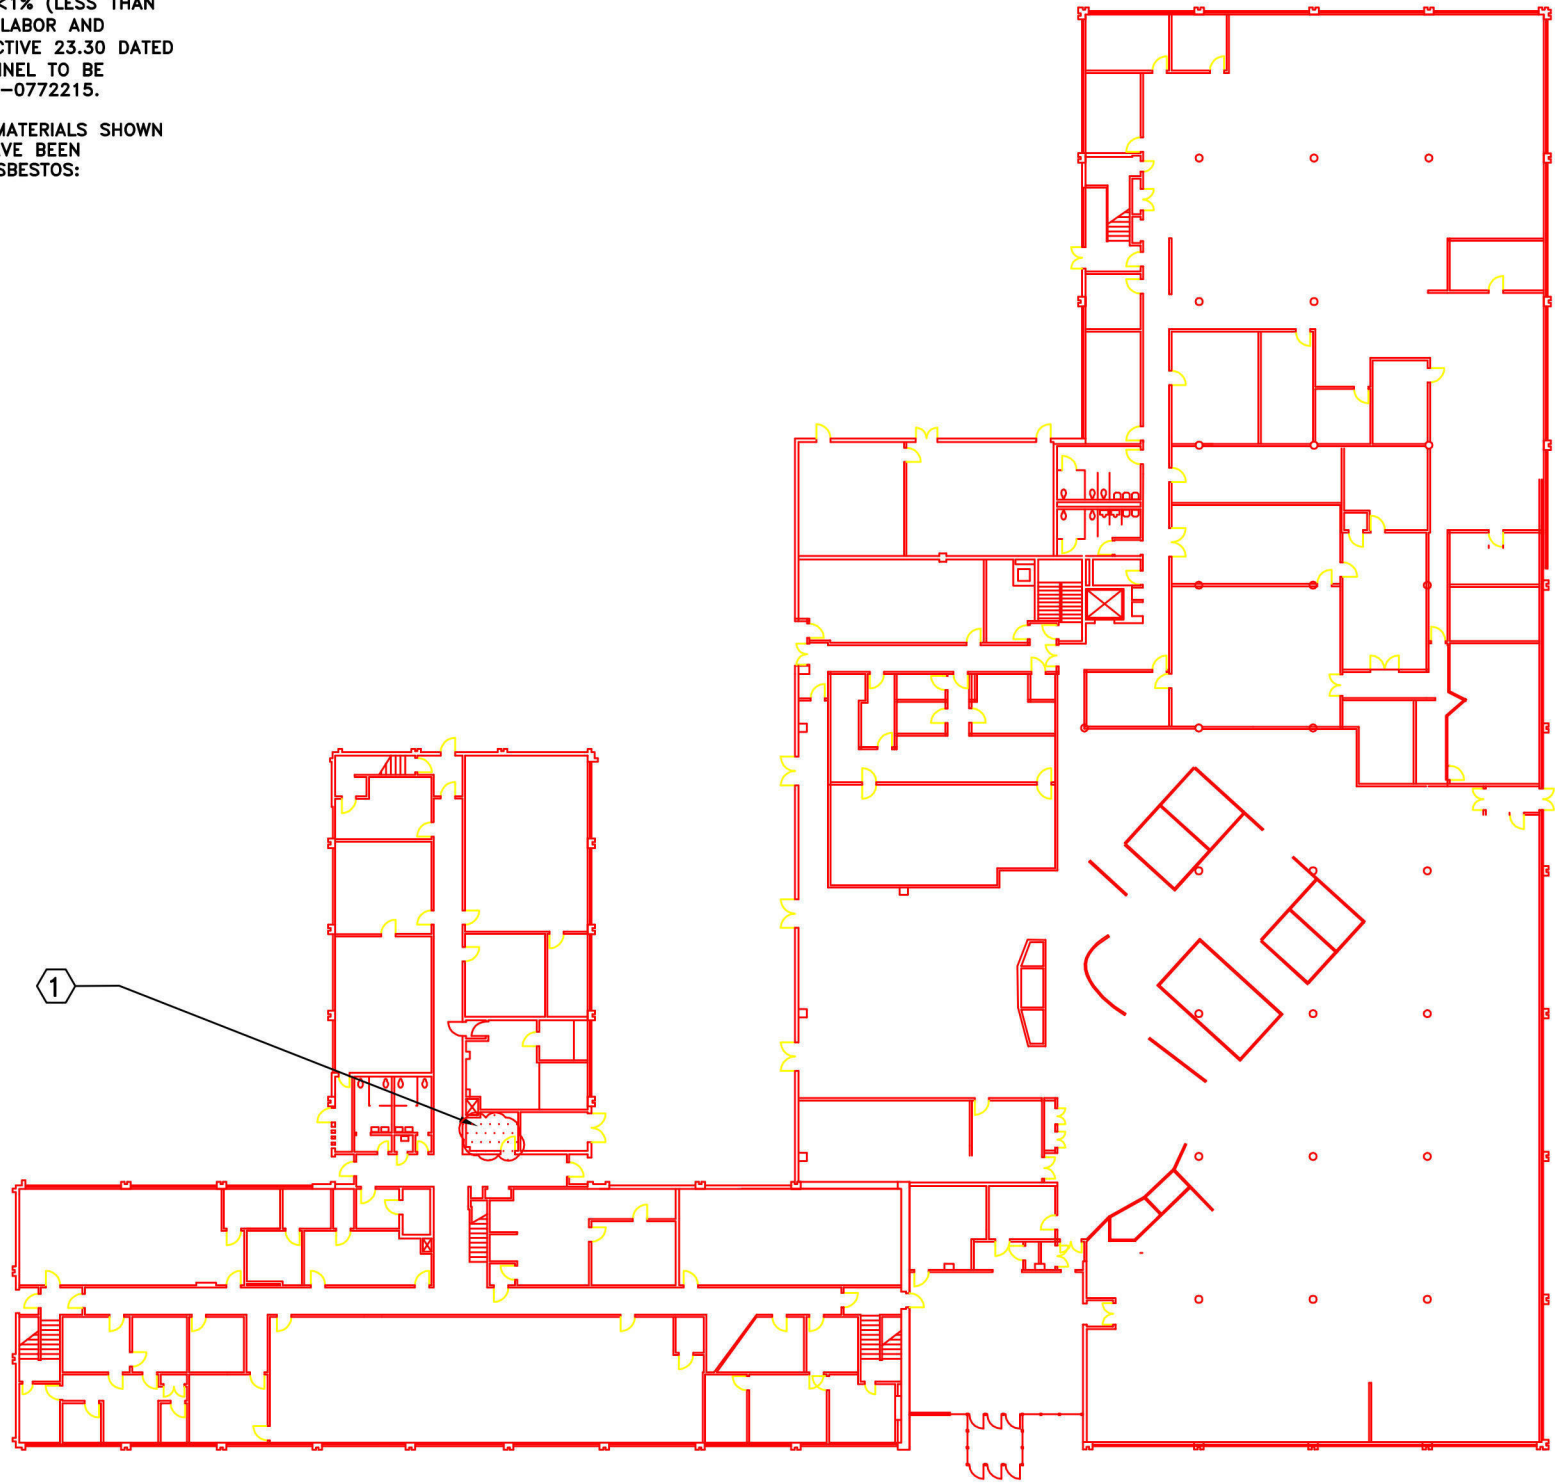
DM - 1

- ① DAMAGED ASBESTOS CONTAINING TSI PIPING.

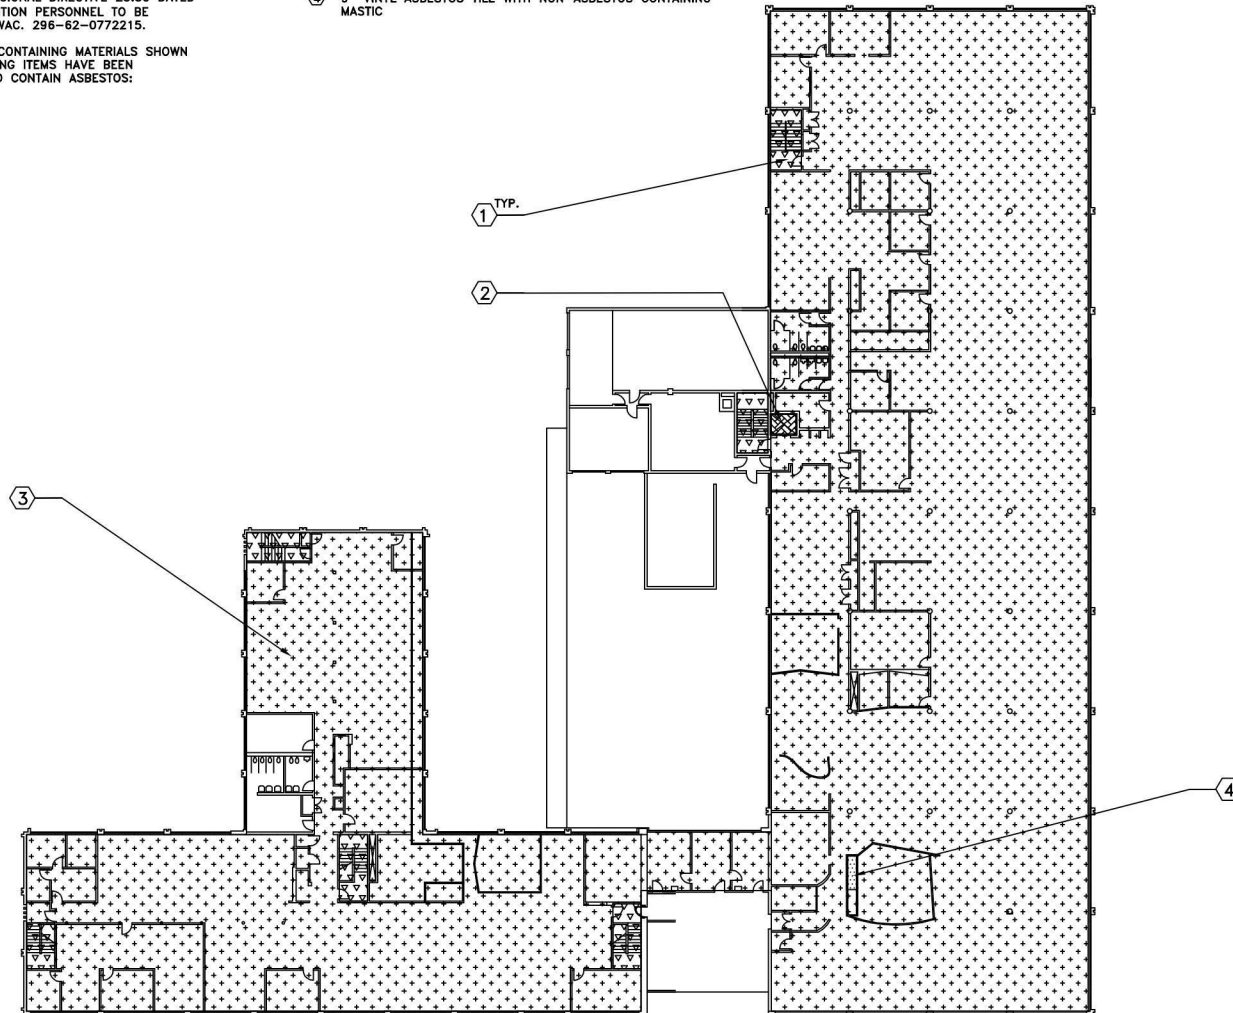
HM - 4.0

- ① ASBESTOS CONTAINING LEVELING COMPOUND UNDER NON-ASBESTOS CONTAINING TREAD FLOORING AND MASTIC, ON CONCRETE
- ② ASBESTOS CONTAINING LEVELING COMPOUND UNDER CARPET AND NON-ASBESTOS CONTAINING CARPET MASTIC, IN ELEVATOR
- ③ CARPET SQUARES OVER 9" VINYL ASBESTOS TILE WITH NON-ASBESTOS CONTAINING MASTIC
- ④ 9" VINYL ASBESTOS TILE WITH NON-ASBESTOS CONTAINING MASTIC

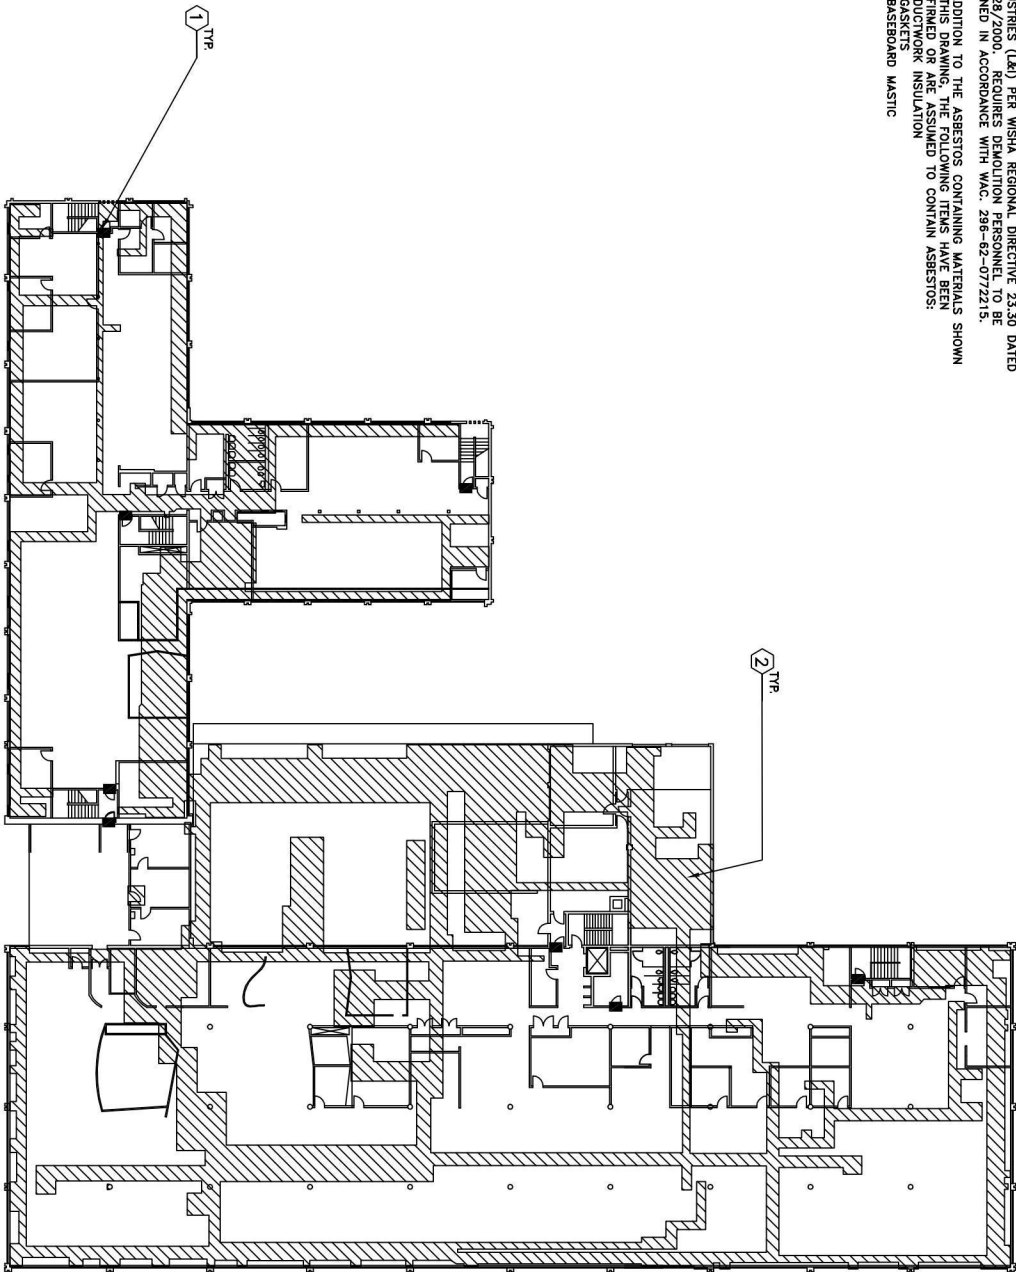
HM - 3.0

- ① ASSUMED ASBESTOS CONTAINING CORE FIRE DOOR
- ② ASBESTOS CONTAINING THERMAL INSULATION ON PIPING (INCLUDES FITTINGS)

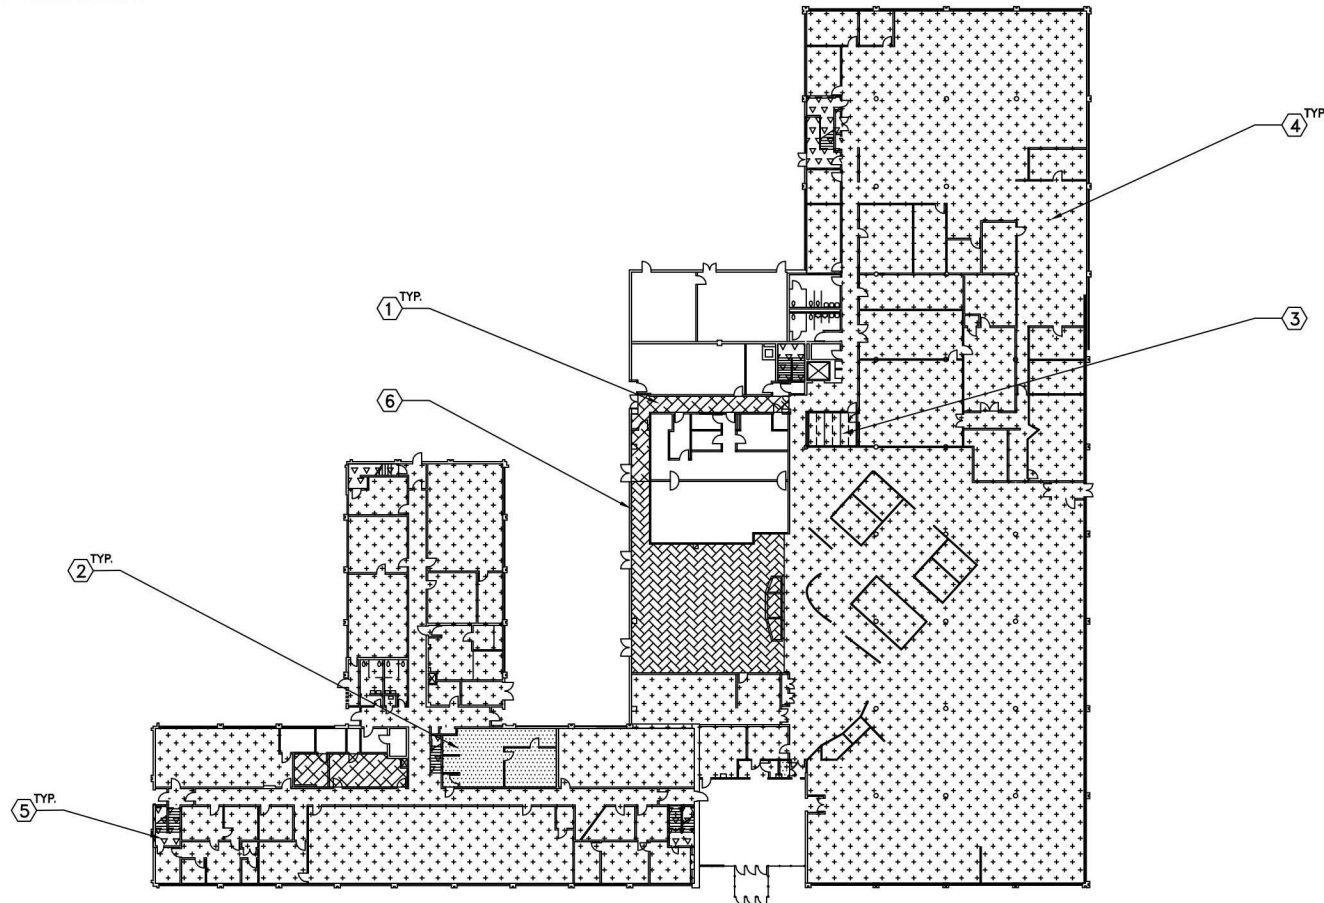
- ① 12" NON-ACM VINYL FLOOR TILE OVER 9" VINYL ASBESTOS TILE WITH NON ASBESTOS CONTAINING MASTIC, ON CONCRETE
- ② 9" VINYL ASBESTOS TILE WITH NON ASBESTOS CONTAINING MASTIC, ON CONCRETE
- ③ ELEVATED FLOORING OVER 9" VINYL ASBESTOS TILE WITH NON ASBESTOS CONTAINING MASTIC, ON CONCRETE
- ④ CARPET SQUARES OVER 9" VINYL ASBESTOS TILE WITH NON ASBESTOS CONTAINING MASTIC, ON CONCRETE
- ⑤ ASBESTOS CONTAINING LEVELING COMPOUND UNDER NON-ASBESTOS CONTAINING TREAD FLOORING AND MASTIC, ON CONCRETE
- ⑥ ASBESTOS CONTAINING LEVELING COMPOUND UNDER NON-ASBESTOS CARPET SQUARES AND CARPET MASTIC, ON NON-ACM BLACK MASTIC AND CONCRETE

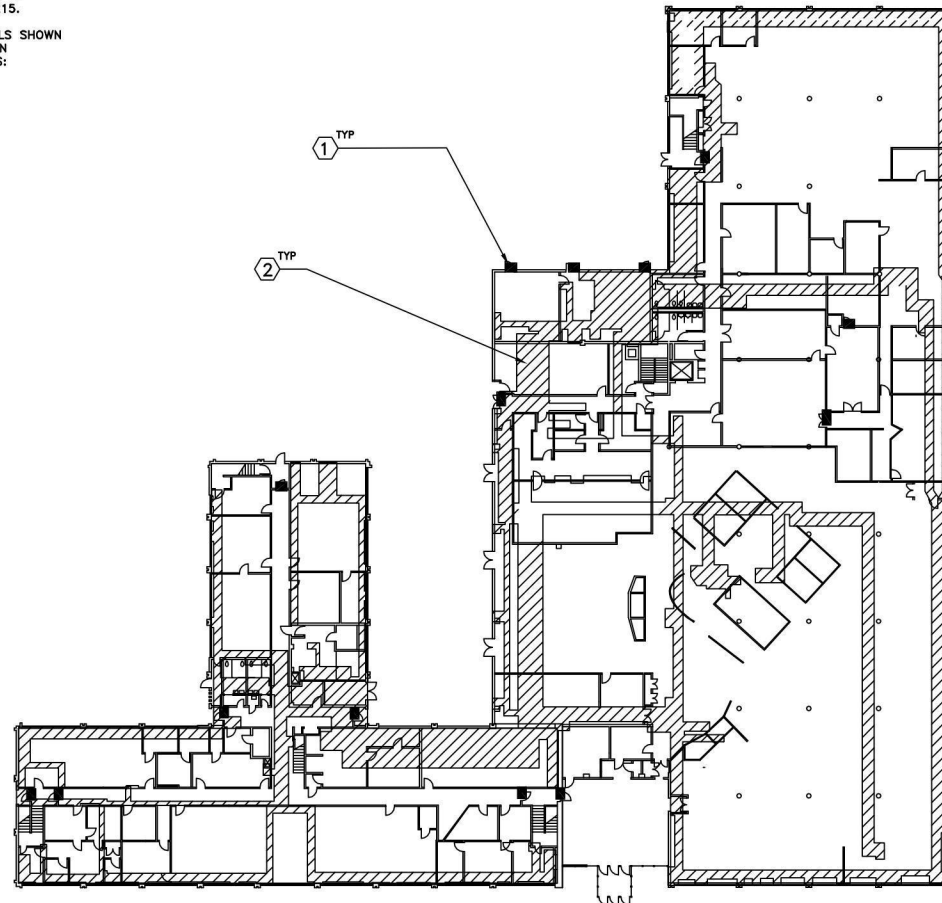
- ① ASSUMED ASBESTOS CONTAINING CORE FIRE DOOR
- ② ASBESTOS CONTAINING THERMAL INSULATION ON PIPING (INCLUDING FITTINGS)
